**DECLARATION OF RENE SMITH**

5. The purpose of this declaration is to present and explain data and pictures evidencing persistent safety violations created on Sumter EMC's electrical distribution poles by attaching entities.

**TAB 1**

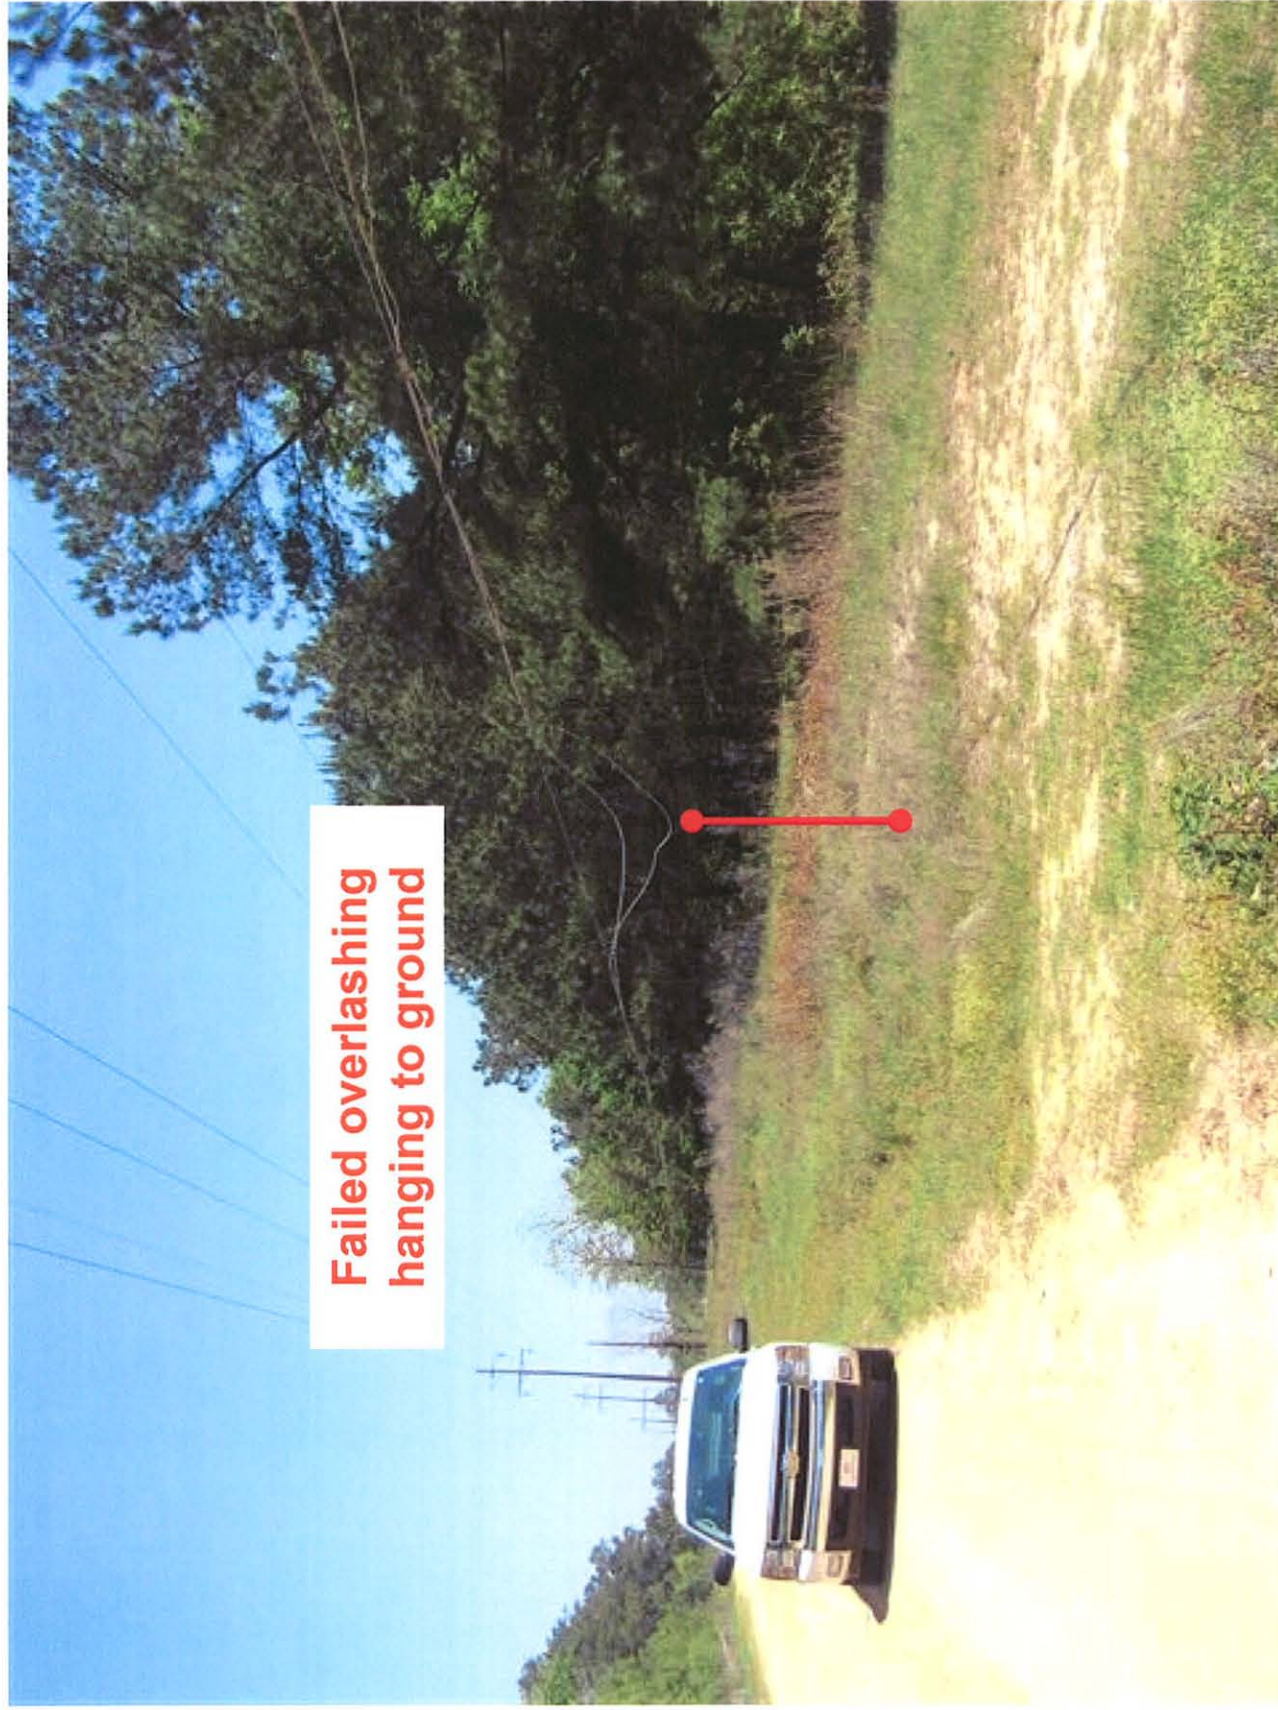
**Failed overlash  
hanging to ground**

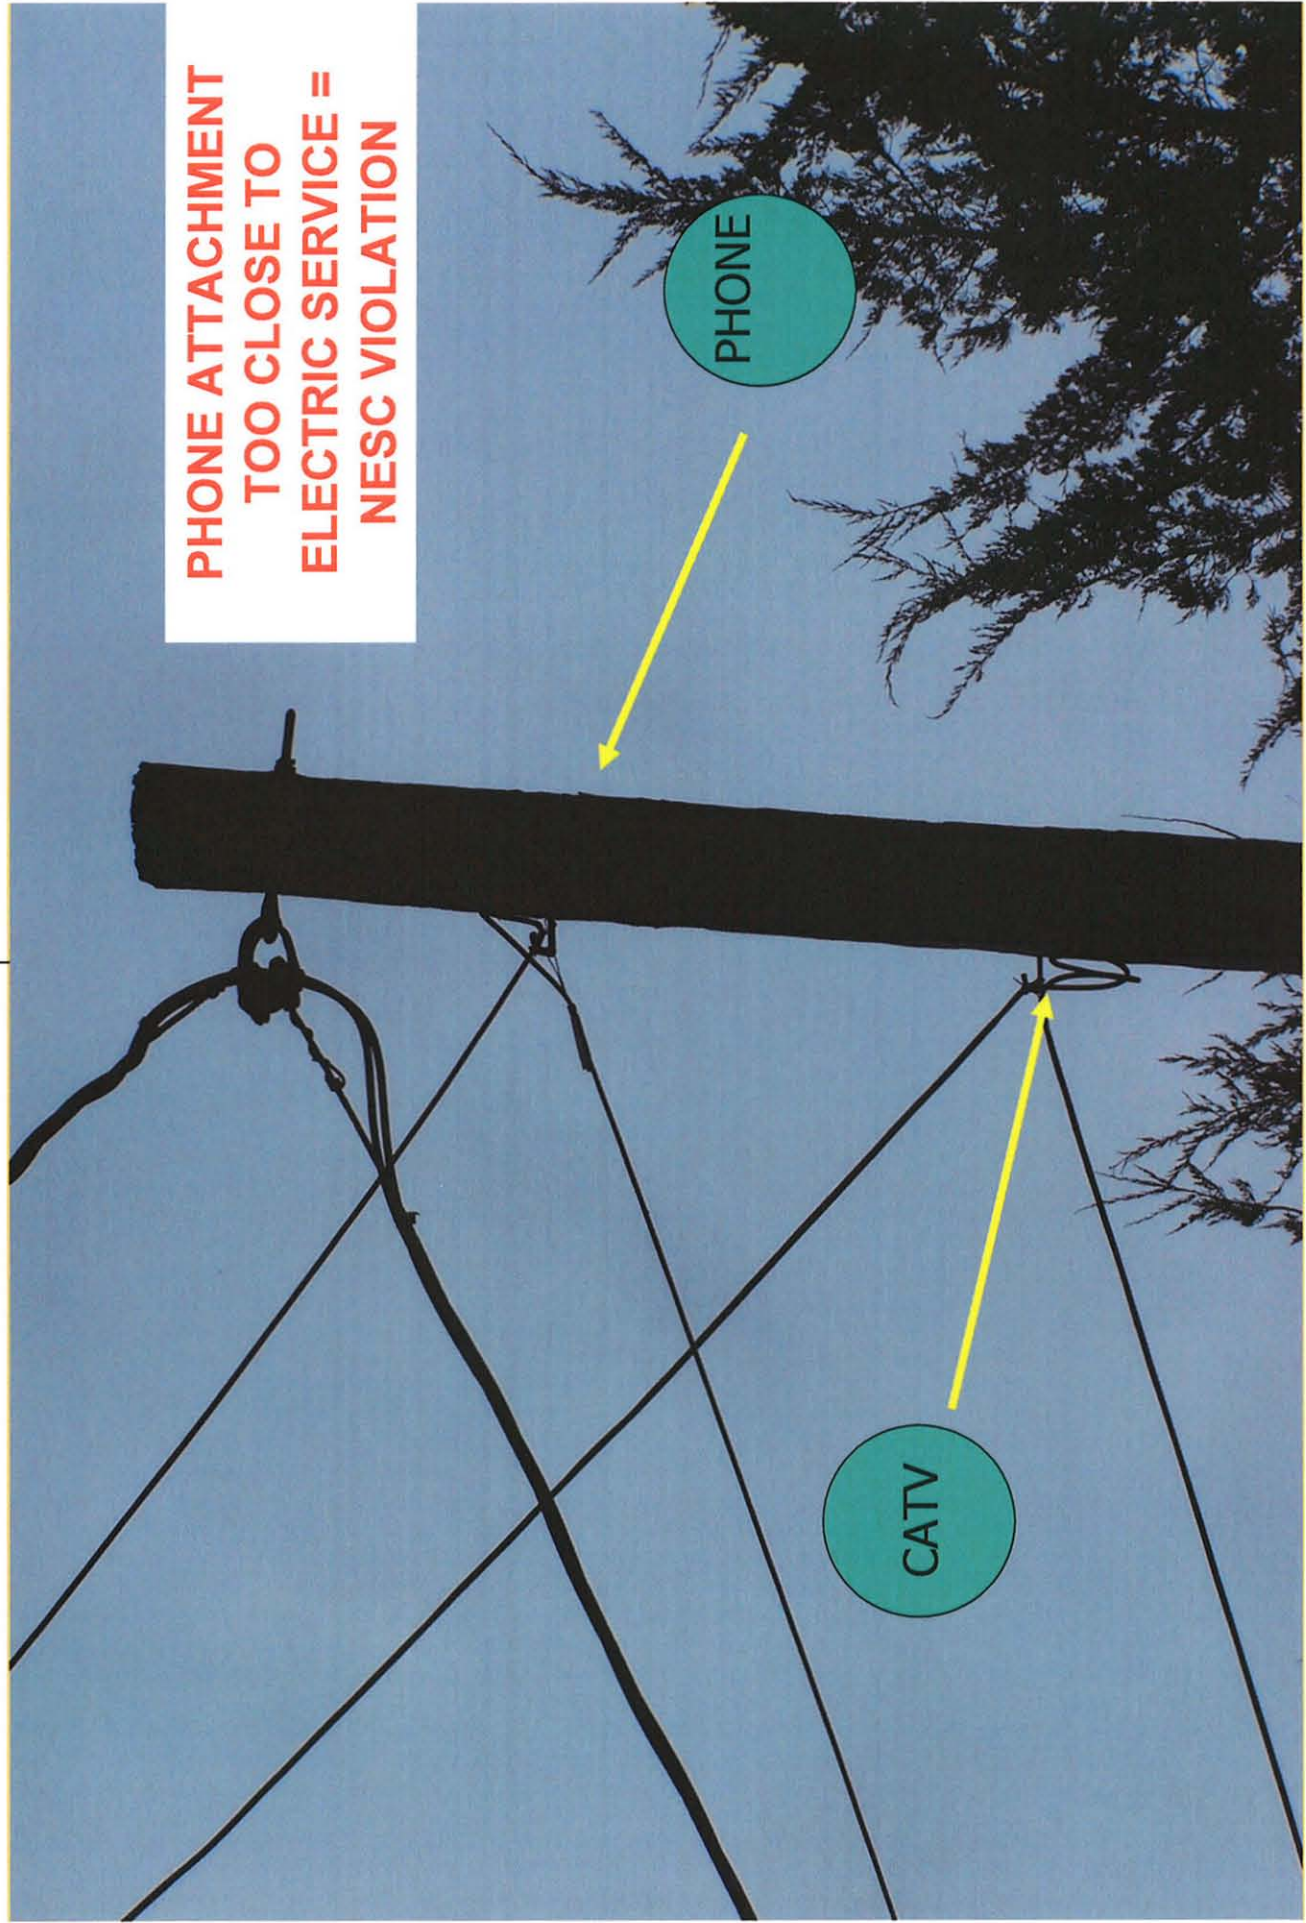
**PHONE ATTACHMENT  
TOO CLOSE TO  
ELECTRIC SERVICE =  
NESC VIOLATION**

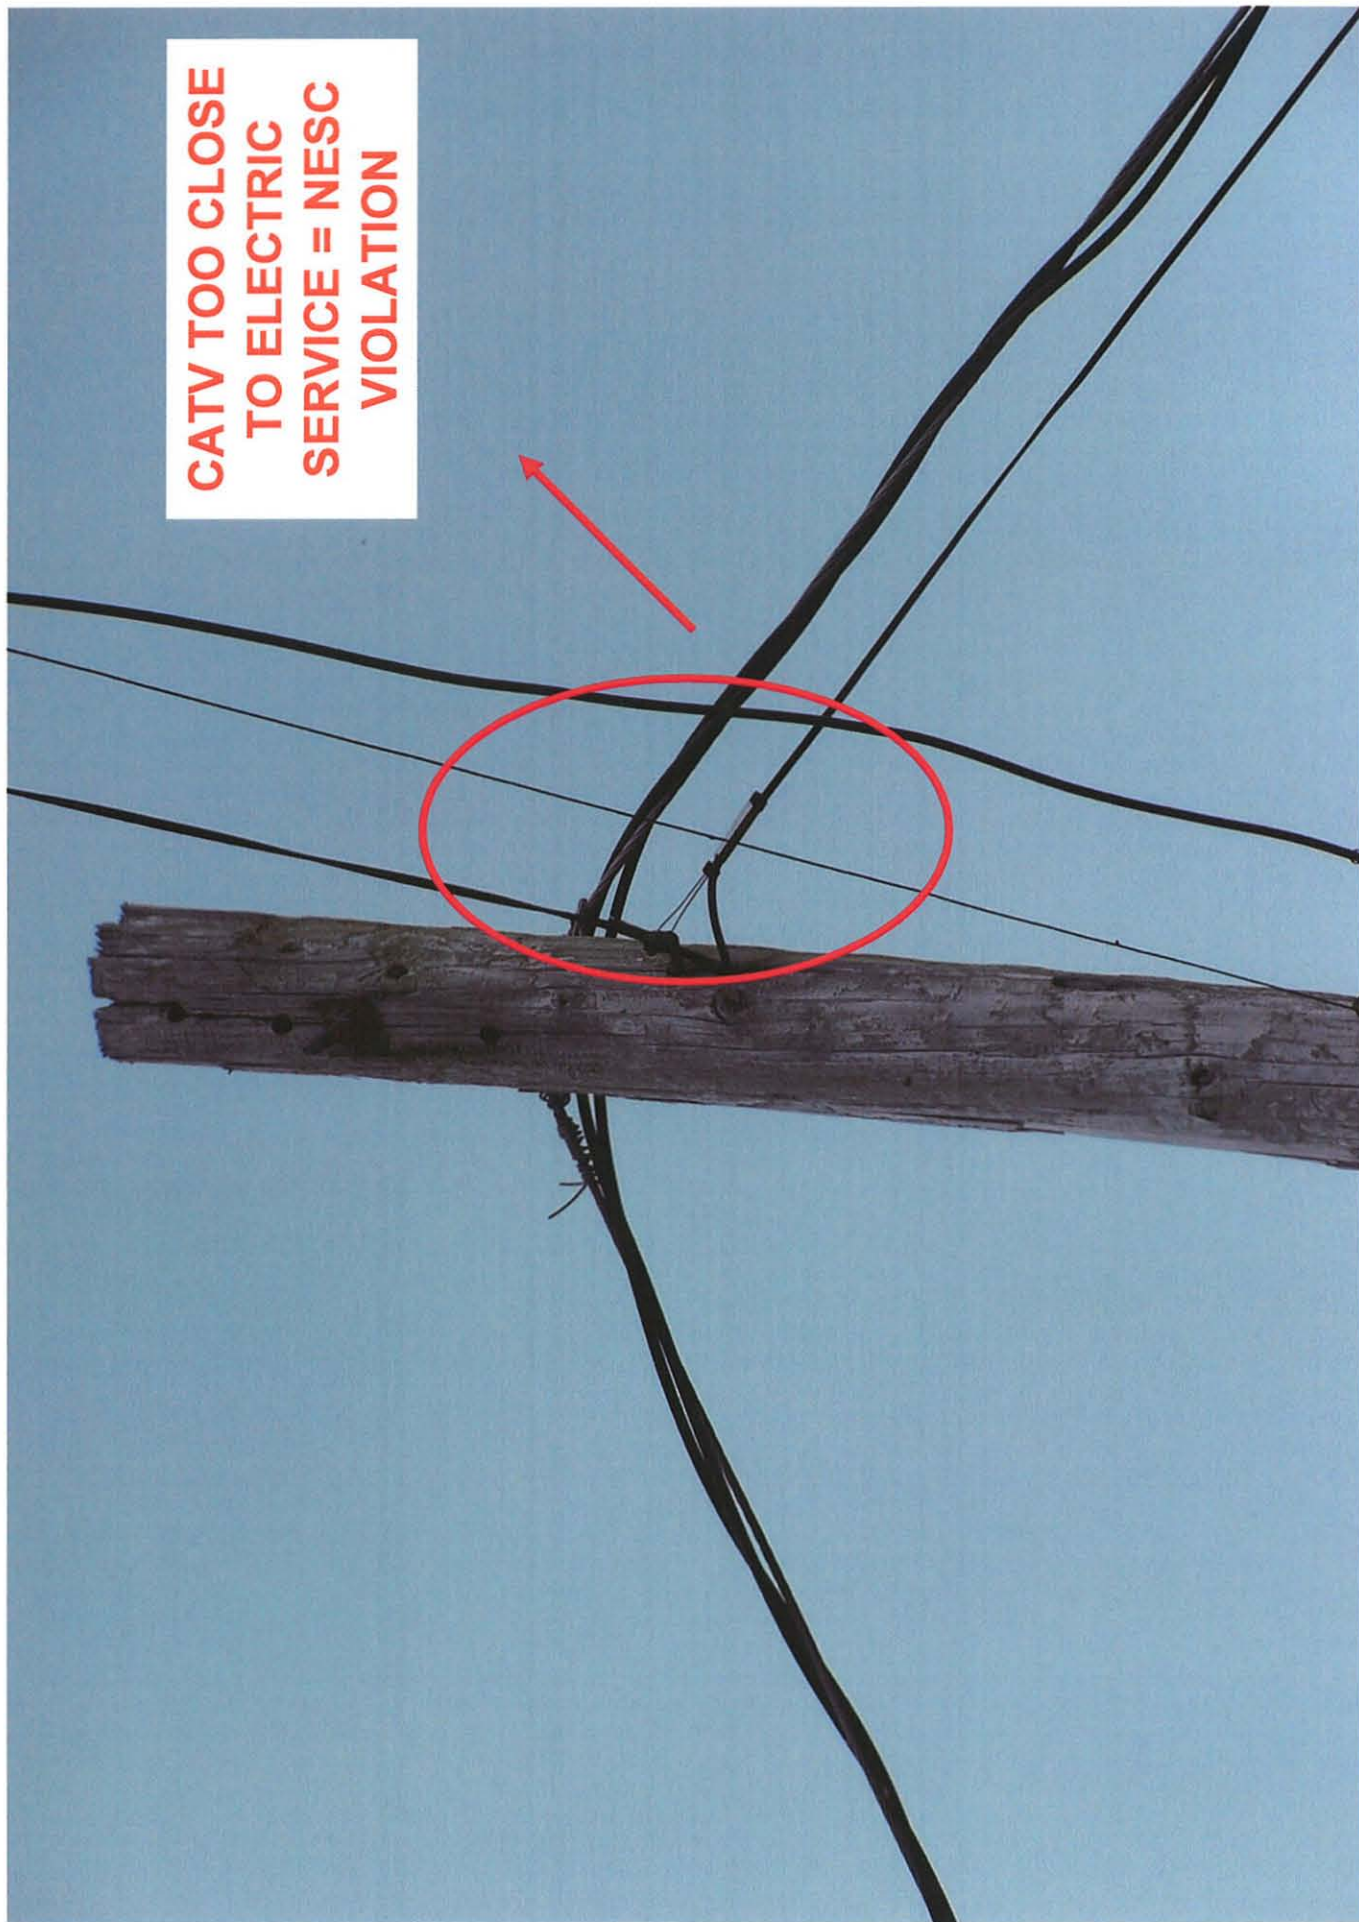
**CATV TOO CLOSE  
TO ELECTRIC  
SERVICE = NESC  
VIOLATION**

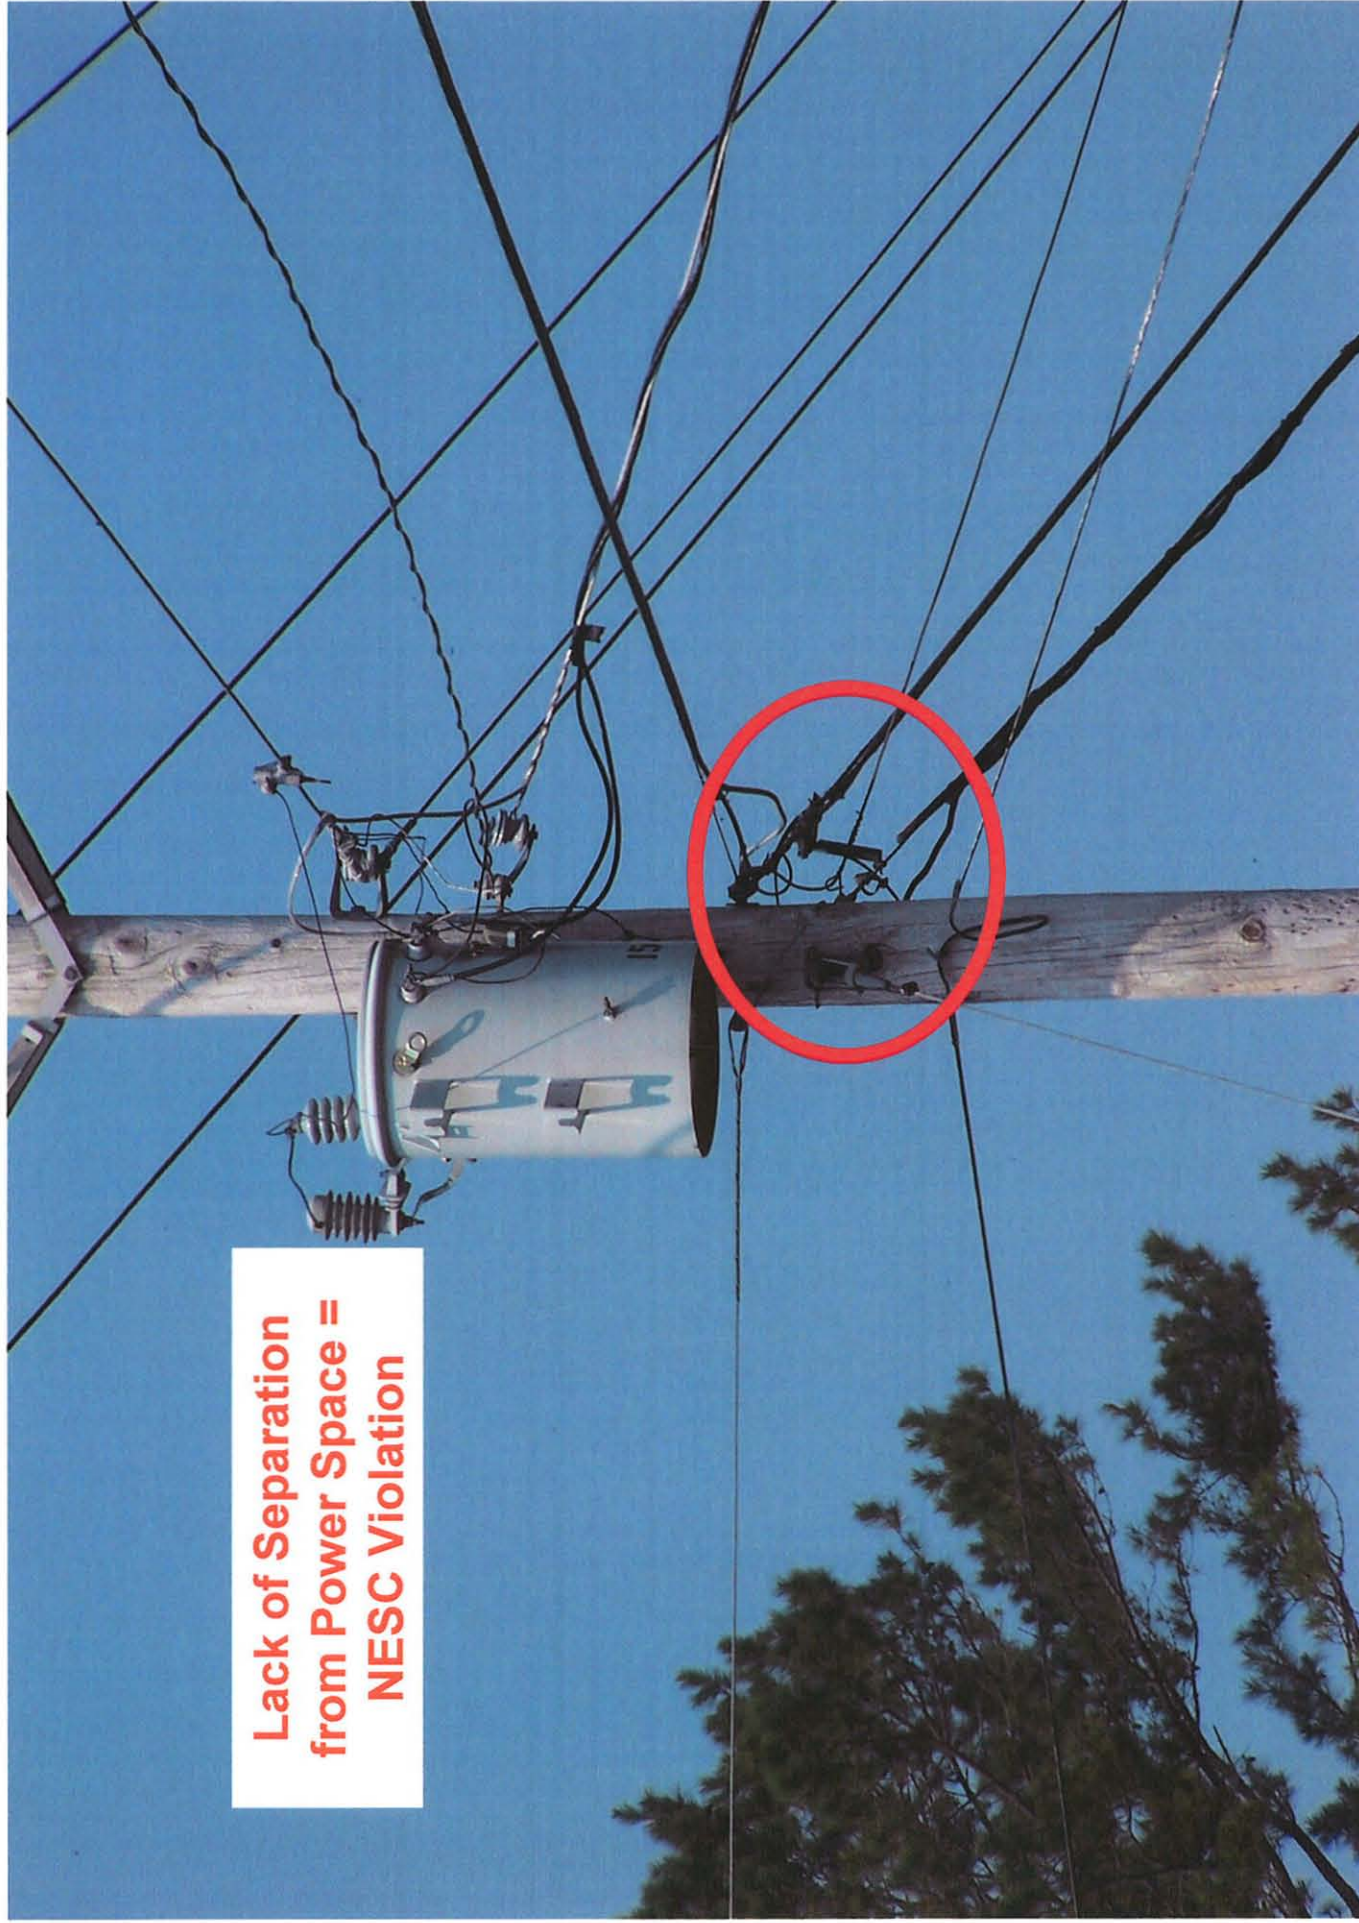
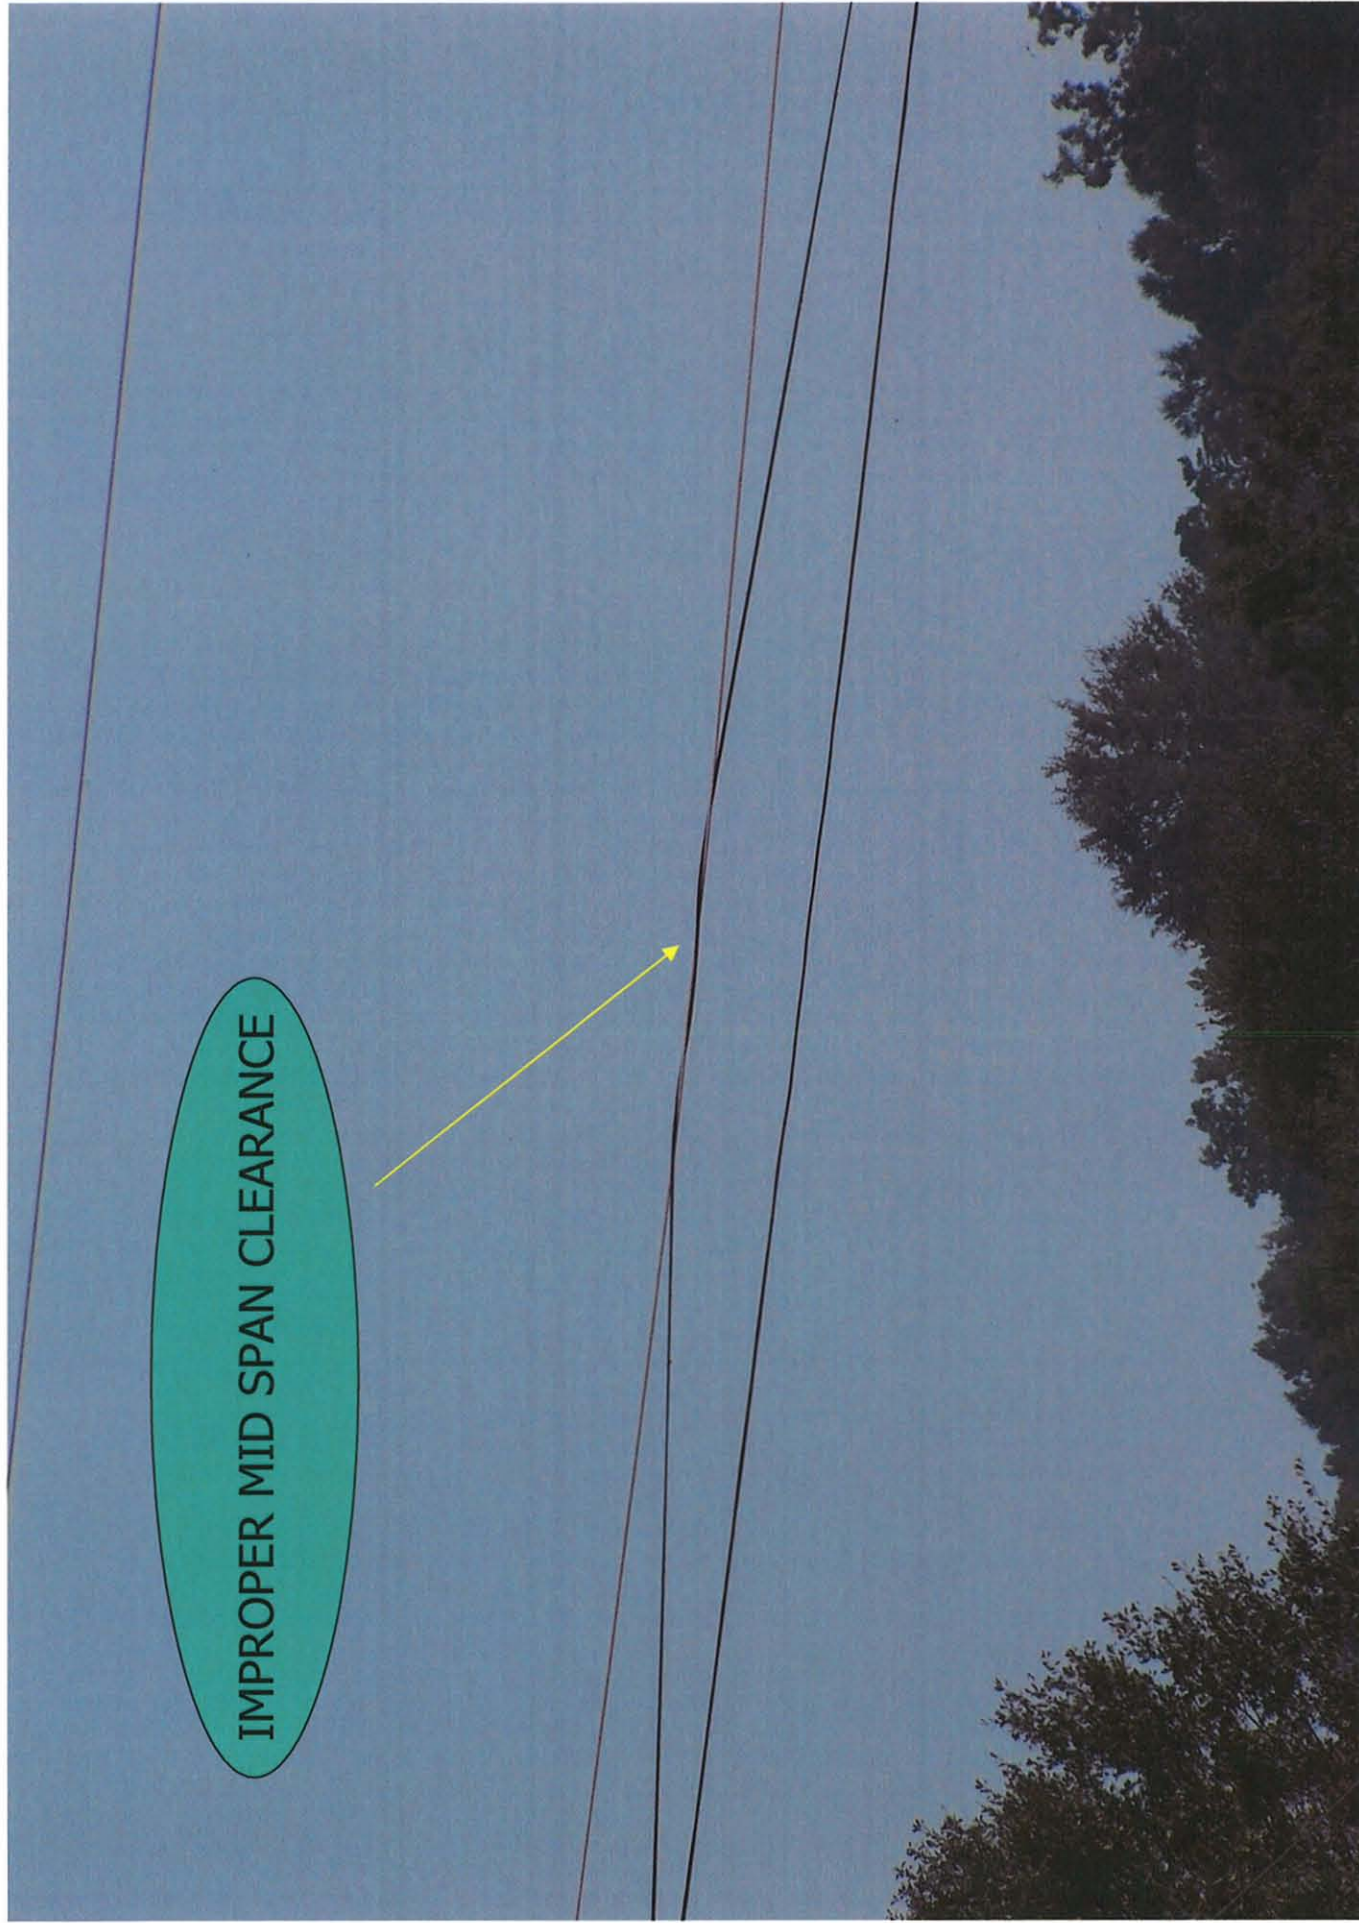
**Lack of Separation  
from Power Space =  
NESC Violation**

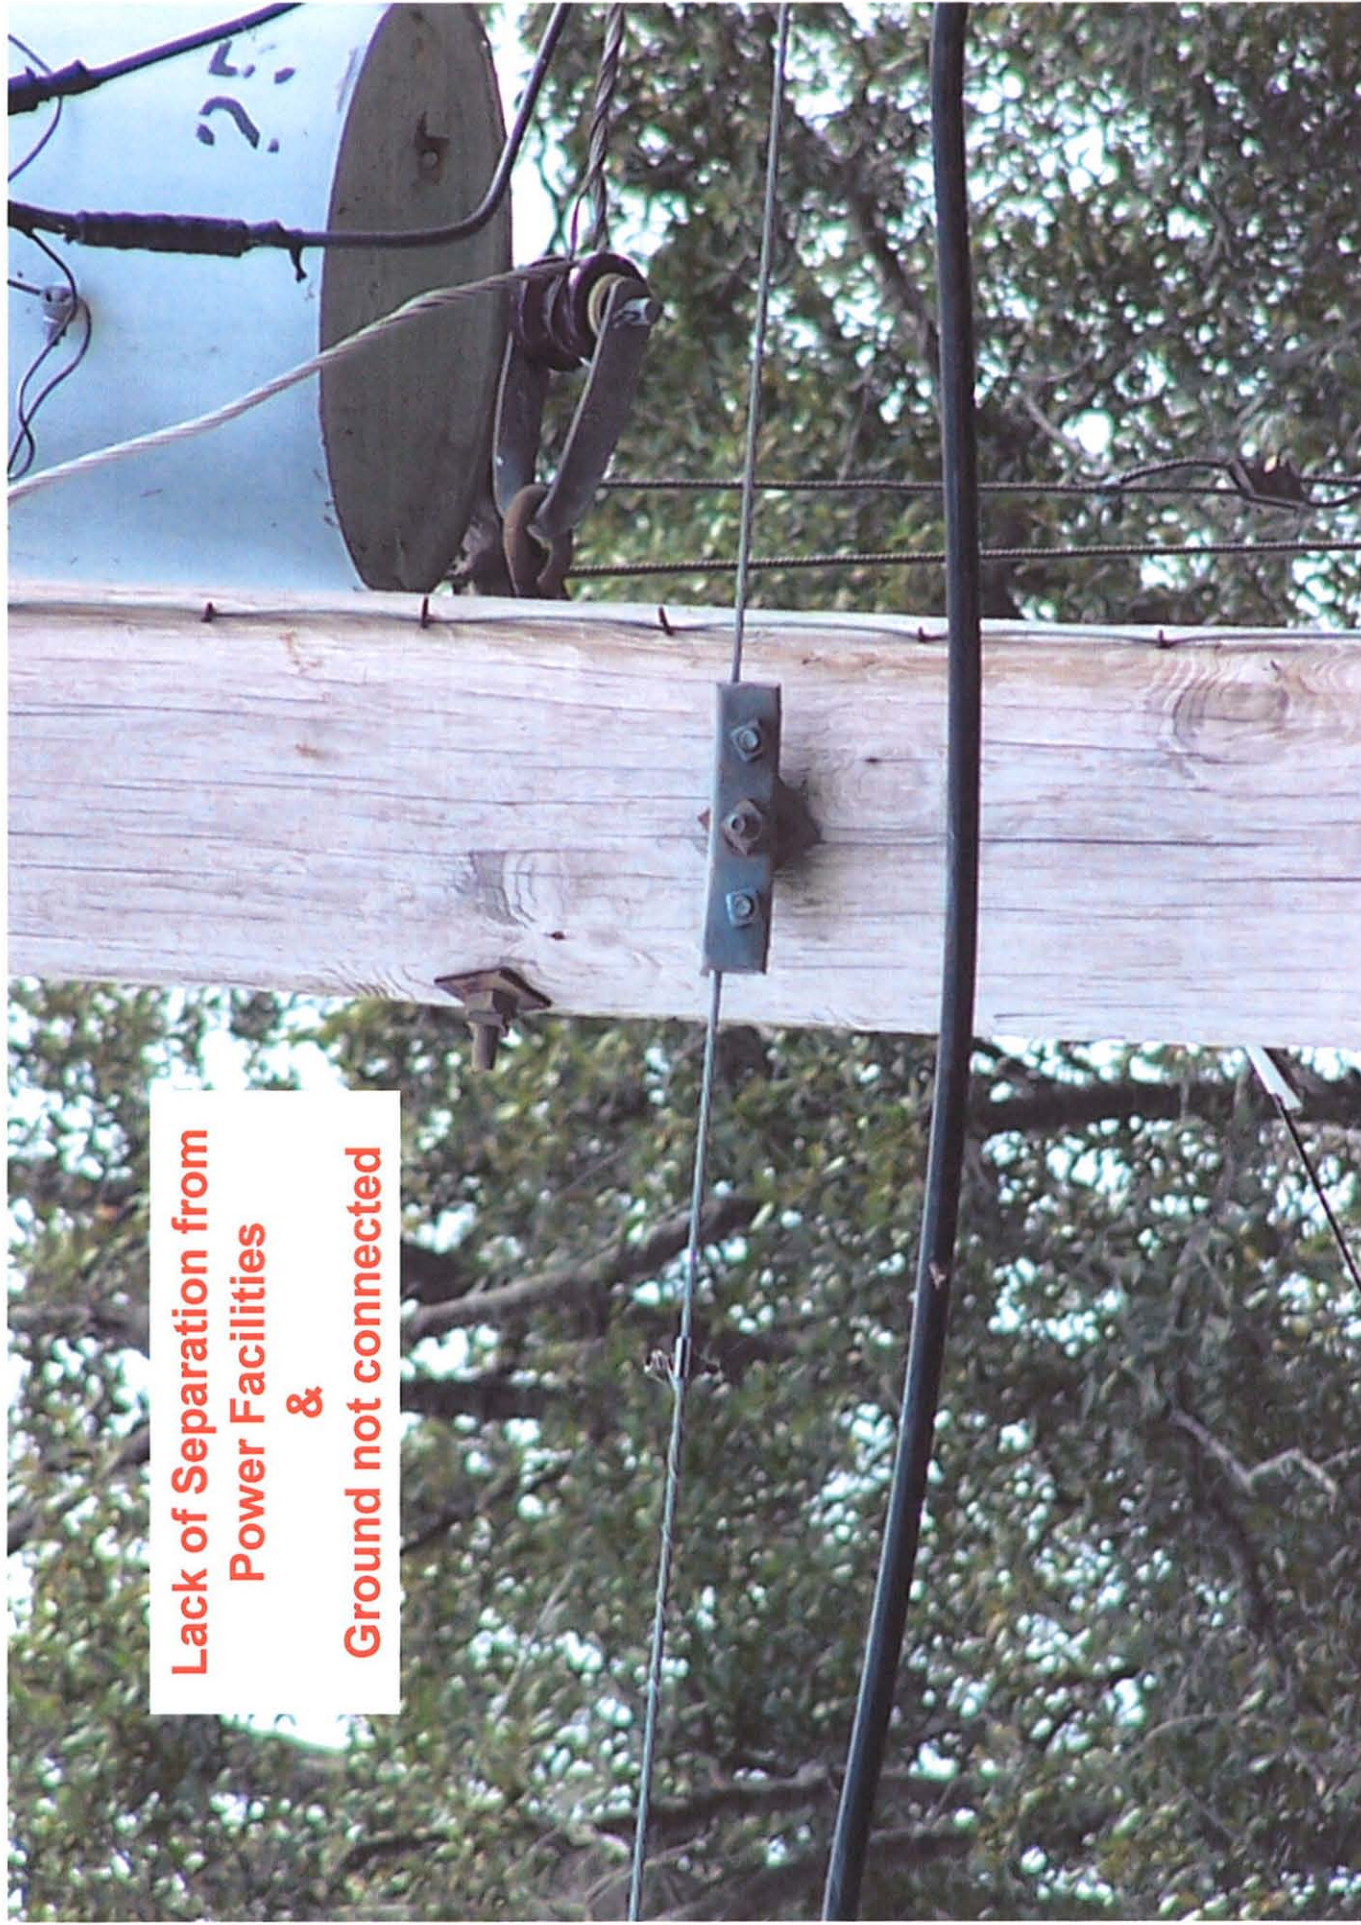
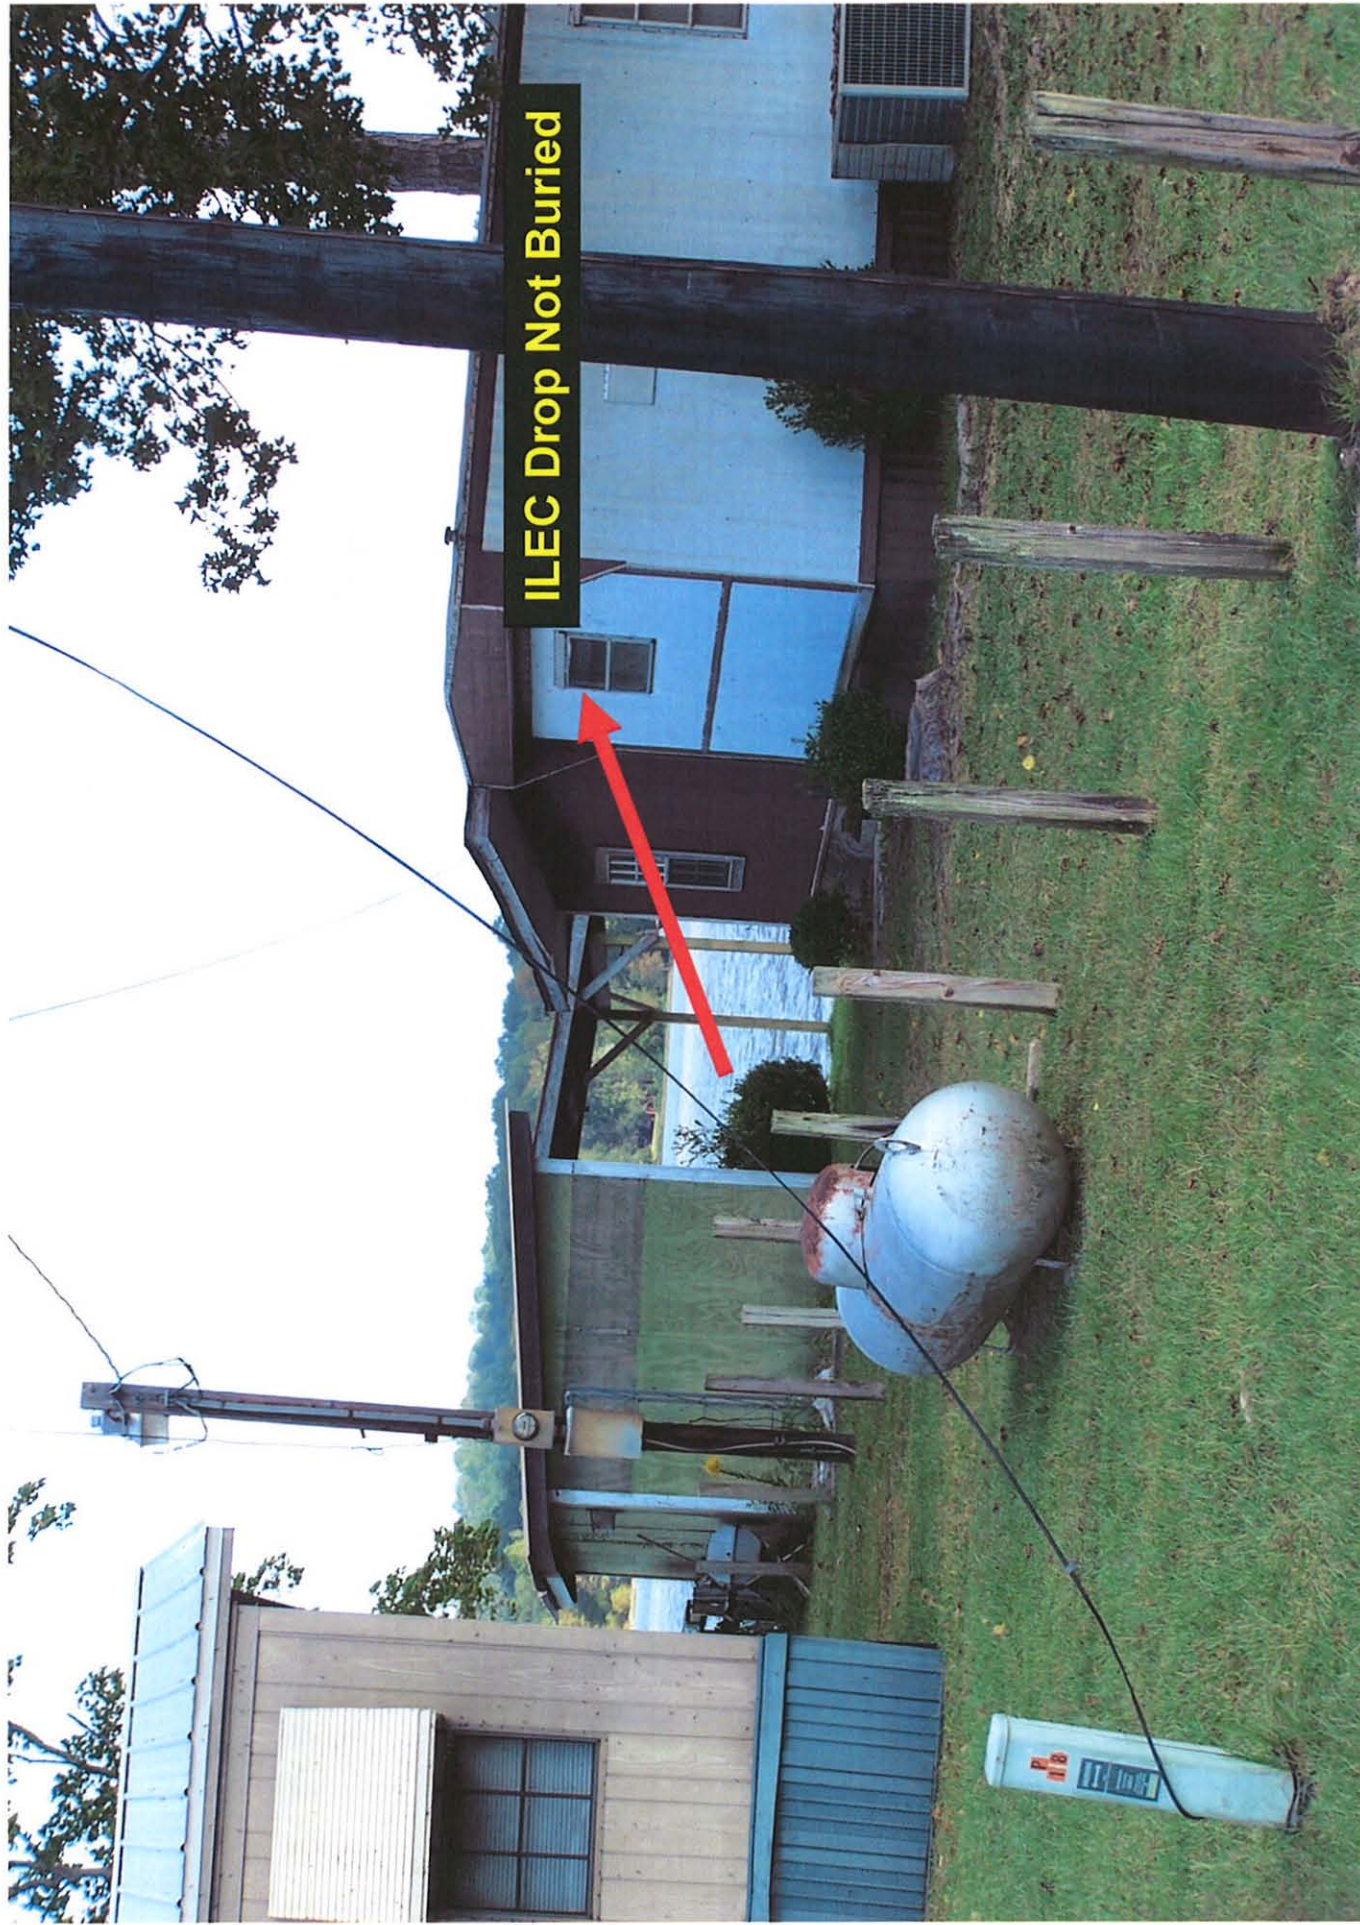
**Lack of Separation from  
Power Facilities  
&  
Ground not connected**

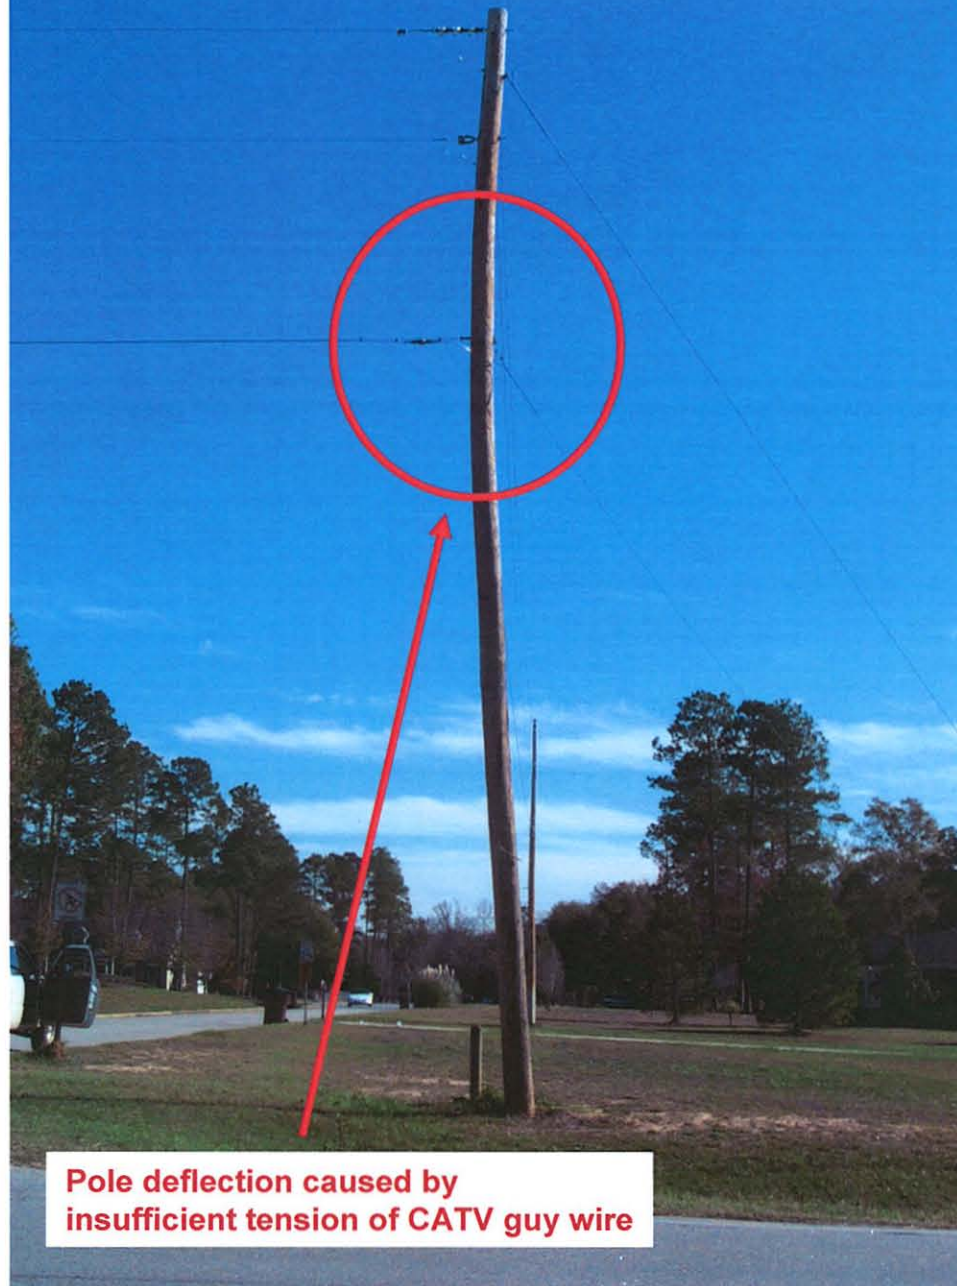
**Date of photograph: 12/19/2001**  
**Location: Lover's Lane at Johns Drive, Leesburg, Ga.**

**Pole deflection caused by  
insufficient tension of CATV guy wire**

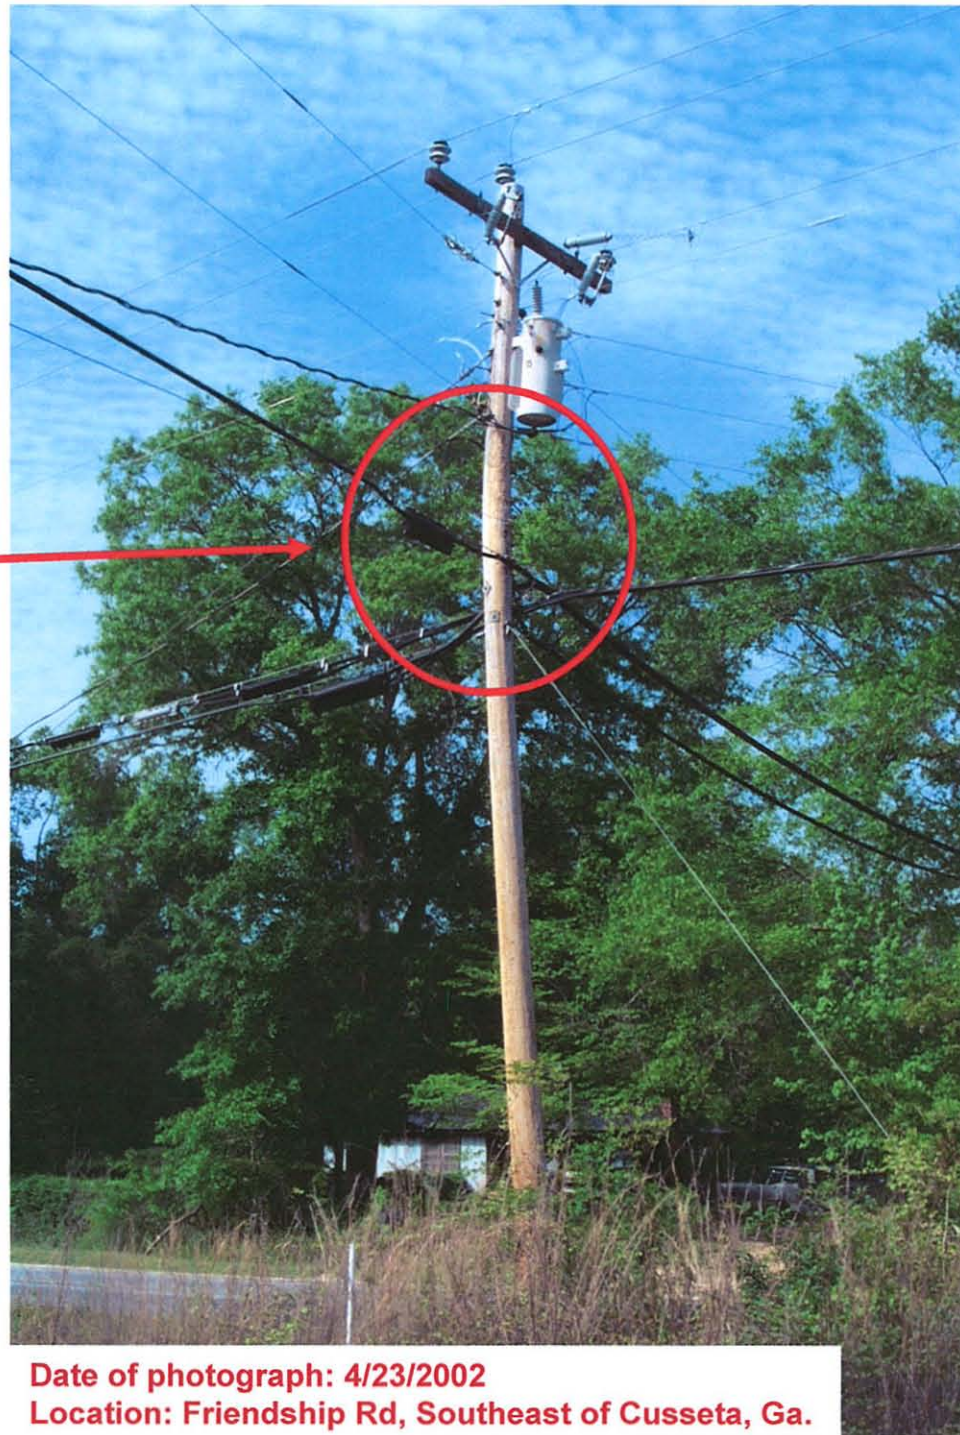
Date of photograph: 4/23/2002  
Location: Friendship Rd, Southeast of Cusseta, Ga.

Pole deflection  
caused by  
improper ILEC  
guying and  
anchoring

Pole deflection caused by improper installation of communication anchor in sandy soil

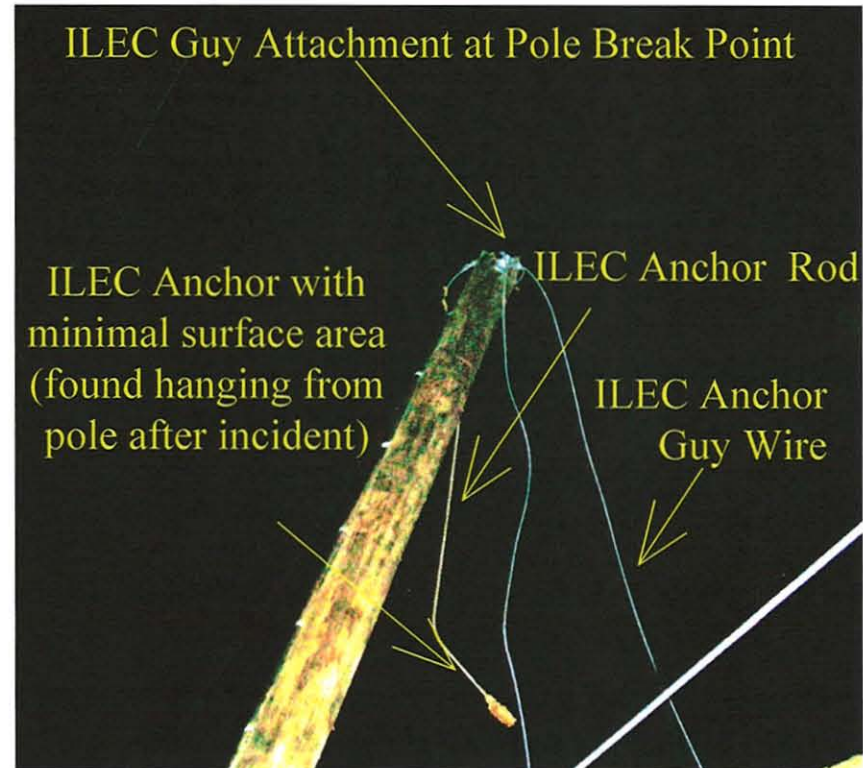
Date of photograph: 11/05/2002  
Location: US27 at Marlette Drive, Cusseta, Ga.

18. The NESC requires that guys be installed as near as practical to the center of the conductor load to be sustained. *See NESC* § 264 (Guying and Bracing), ¶ C. The NESC further provides that guys are intended to limit increase of sags in adjacent spans and provide sufficient strength for unbalanced loads. *Id.* at ¶ A. Sumter EMC guys are installed near the center of power facility loads, and ILEC or CATV guys should be installed near the center of ILEC or CATV loads. Each parties' guys are intended to support their own unbalanced loads on any given structure. If ILEC or CATV guying and anchoring is in accordance with the NESC, removal of Sumter EMC's conductors and guys should not result in failure of the guy that remains on the pole. Obviously that is what happened in this instance.

# Pole Deflection – 9 months after Construction

Photo of pole 1 from the previous slide after a dump truck contacted the sagging communications cable crossing a 4-lane highway.

ILEC anchor #1 can be seen hanging from the pole top. (broken pole is leaning, but still standing)

The ILEC anchor and rod had minimal holding power in the sandy soil and they were pulled from the ground with sufficient speed to contact the overhead 25kV power line

ILEC Anchor #2 was pulled clear of the earth after the pole was broken and the full tension of telephone cables was applied to ILEC Anchor #2 (after pole was broken, power cables no longer helped hold the pole in place below the break point)

ILEC Anchors 1 and 2 are 'Manta-Ray' anchors which have little holding power in loose soils
